**Geomorphic Assessment & Restoration Prioritization Report**  
Middle & West Fork Teanaway Rivers in areas within the Teanaway Community Forest

Mid-Columbia Fisheries Enhancement Group  
413 N. Main Street, Suite K  
Ellensburg, WA 98926  
(509) 281-1311

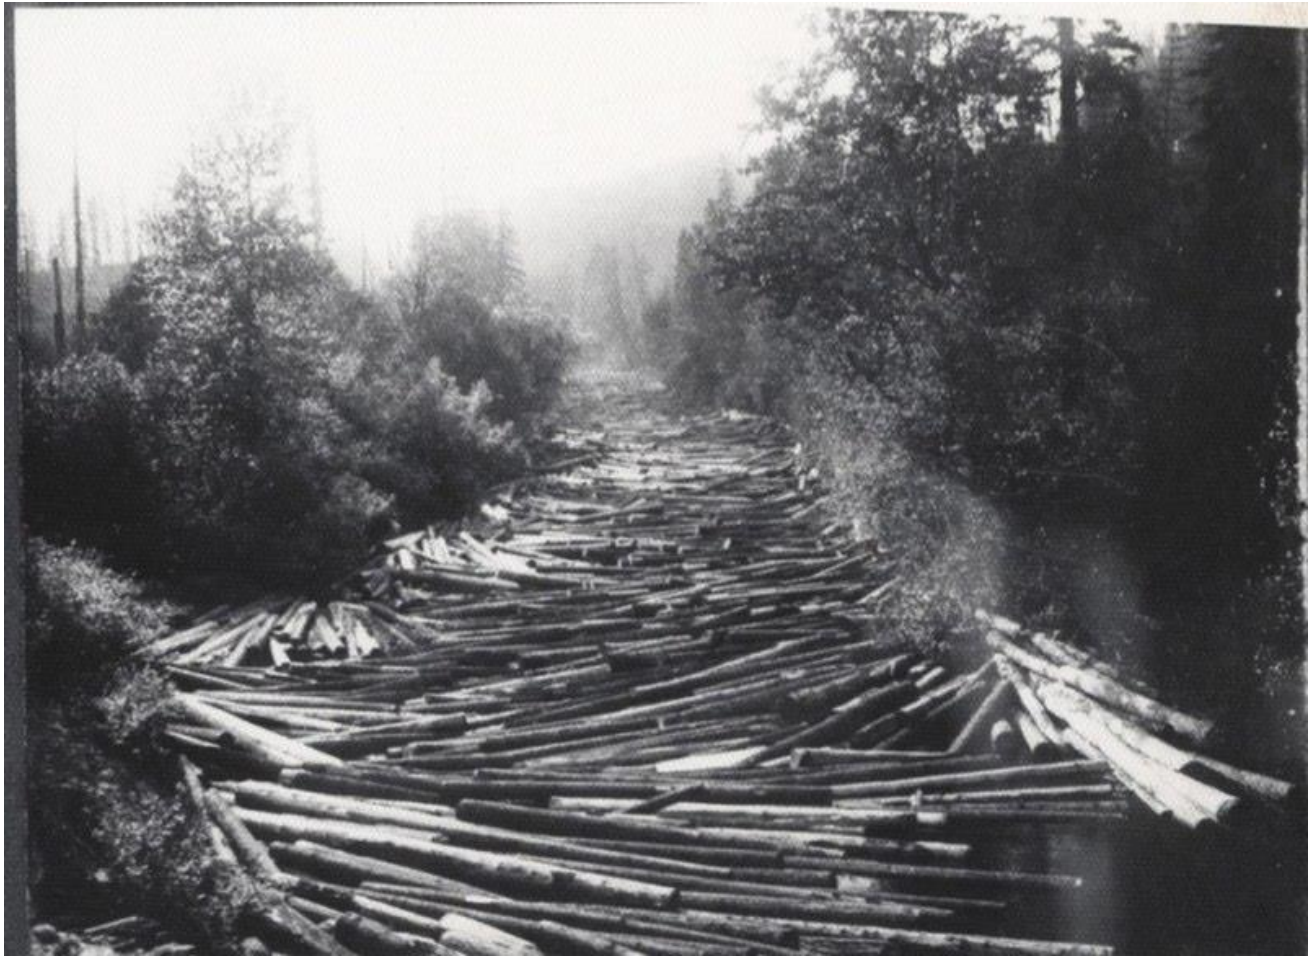
**Figure 3. Log Drive in the Teanaway River**

*Sawed logs staged in the channel and then sent downstream through splash damming which created an artificial flood peak laden with logs. To enable wood transport natural wood accumulations in the rivers were removed. These events severely eroded channels where they occurred. Photo from CWU Library.*

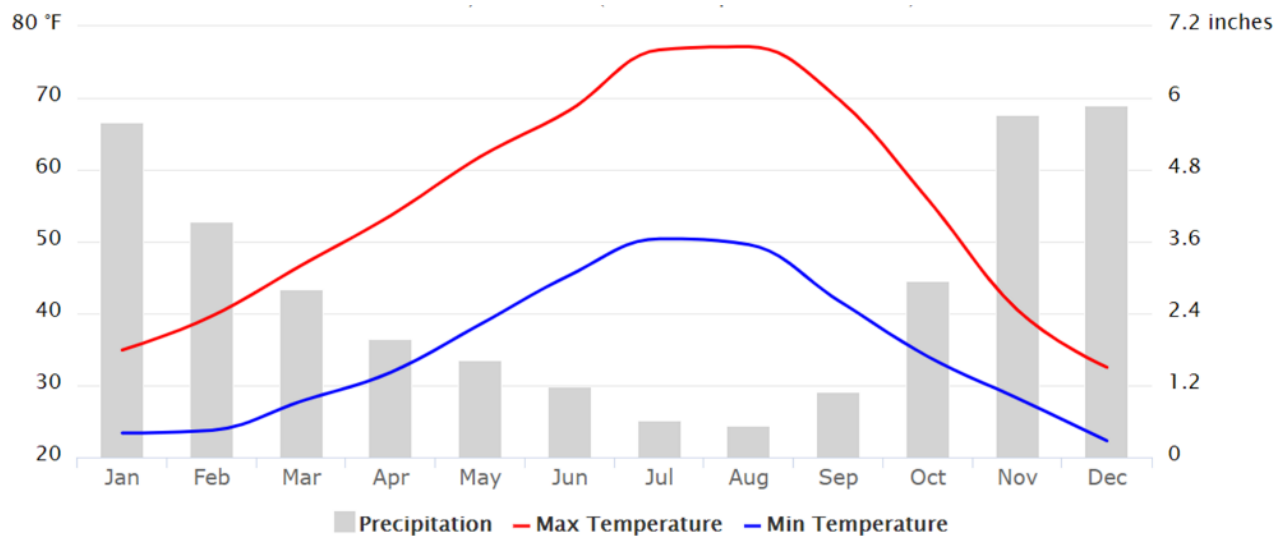
Figure 7. Temperature and Precipitation (1981-2010 Normals) at the Confluence of the MF and WF Teanaway  
Data & plot from Hegewisch & Abatzoglou.

The Teanaway watershed has hot (81 °F), dry summers and cold (25°F), snowy winters, with mean annual precipitation ranging from 20 in yr<sup>-1</sup> in the lower basin to 90 in yr<sup>-1</sup> in the upper watershed, 80% of which falls as snow between October and March (Amec, 2013; PRISM, 2021). The WF receives an average of 51 in yr<sup>-1</sup> and the MF receives an average of 56 in yr<sup>-1</sup> (PRISM, 2021). Temperatures are lowest in December through January and highest in August, with the greatest precipitation falling in November, December, and January (Figure 7).

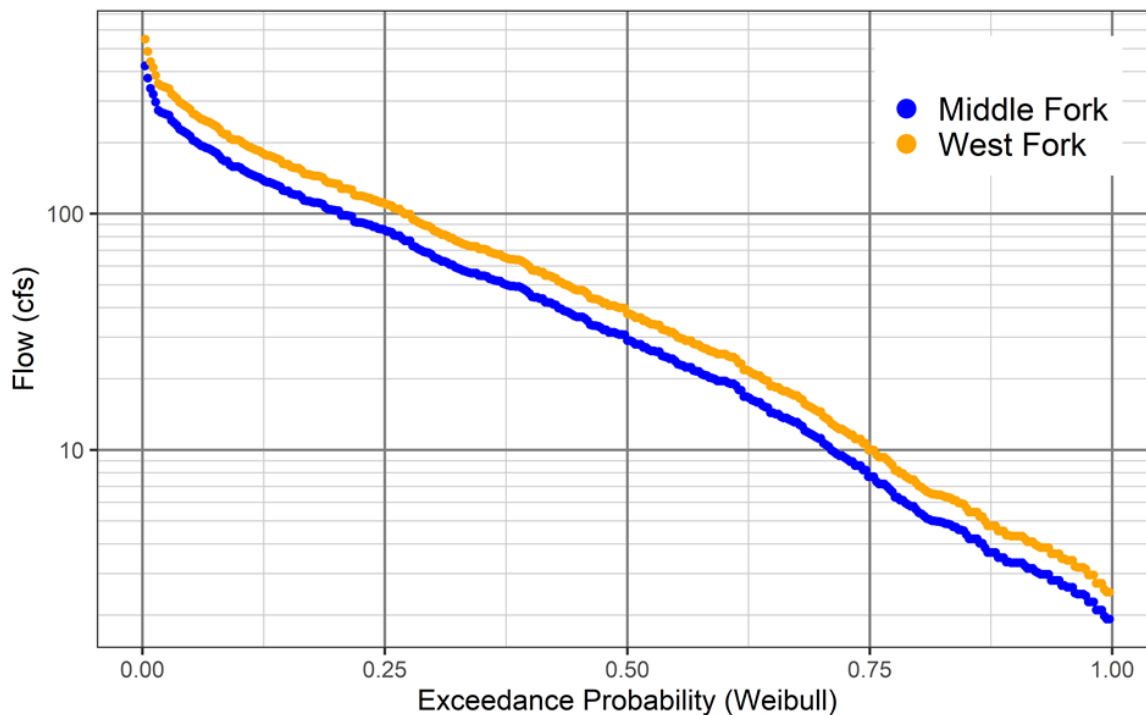
**Figure 11. Estimated exceedance flow probabilities for the MF and WF**  
 Scaled from the mainstem Teanaway gage (USBR TNAW)

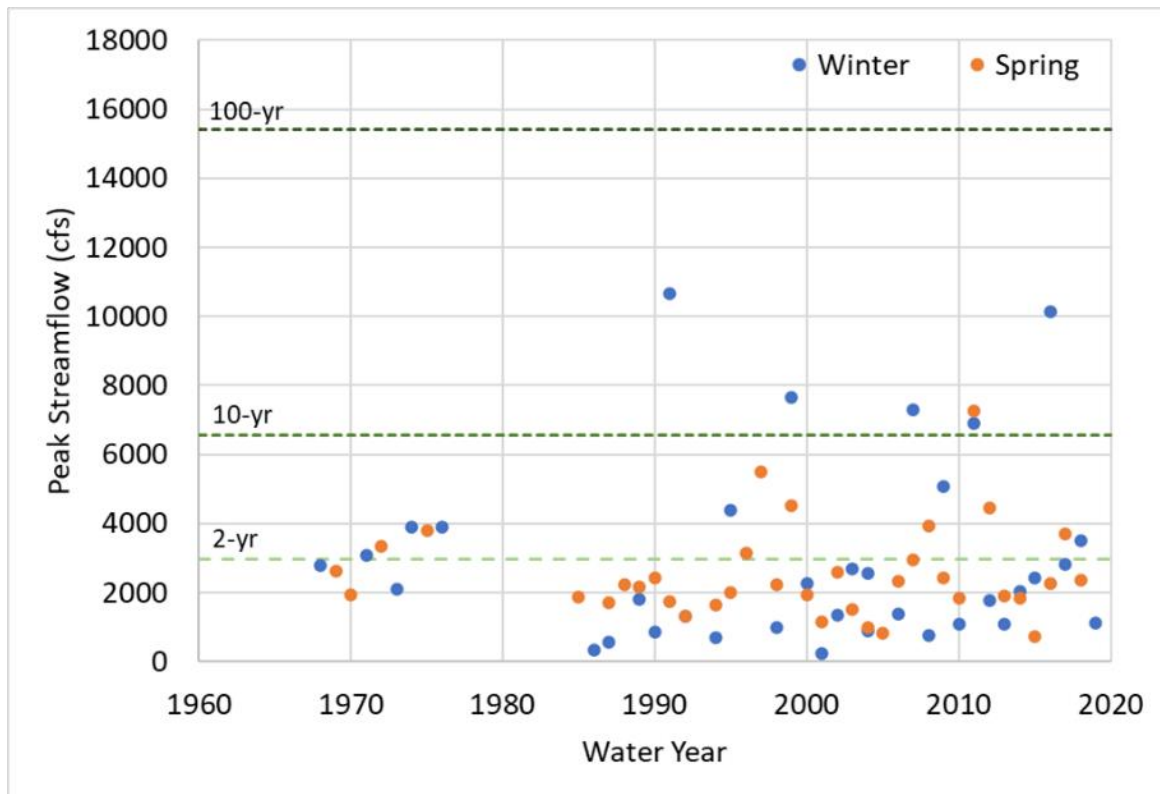
Figure 12. Peak Flows for the TNAW Gage Site Below the Forks

*Dashed horizontal lines indicate peak flow recurrence estimates determined by Chris Lynch (USBR).*

Table 4. Review of these estimates compared with those derived in USGS StreamStats or on shorter gage records at the USGS or WA Ecology gage sites suggests these peak flow recurrence intervals provide a reasonable estimate of peak flow runoff in the Teanaway.

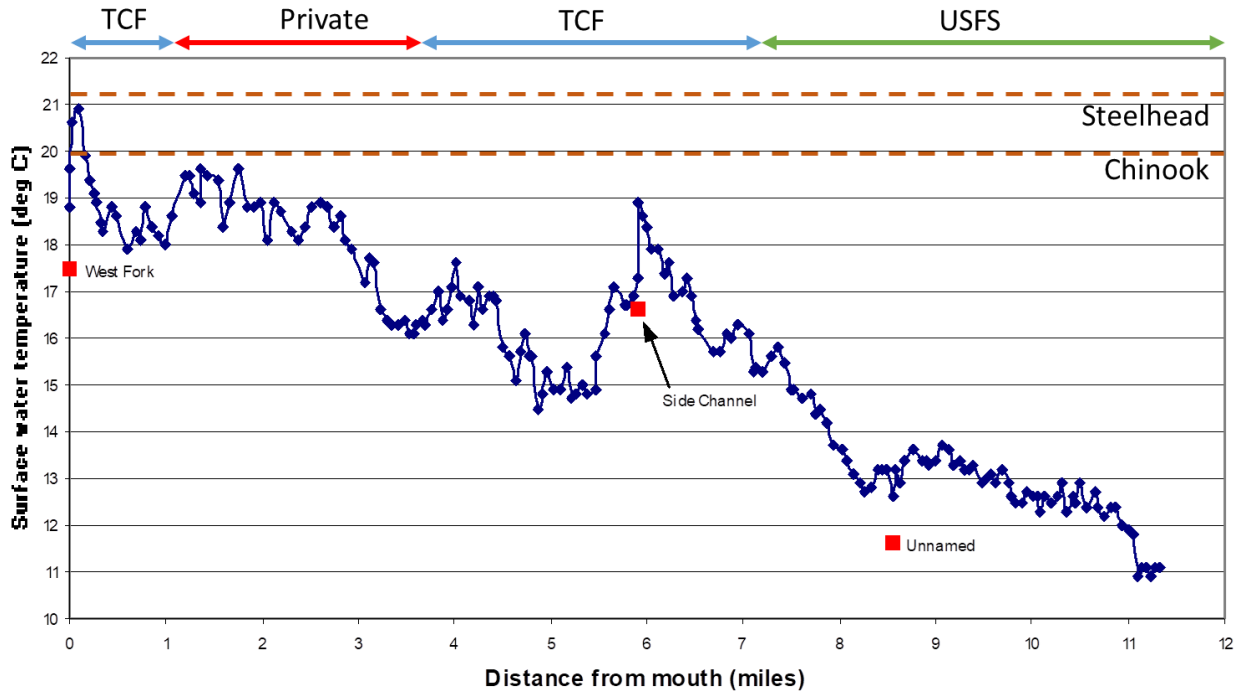
**Figure 15. TIR Temperature Profile for the Middle Fork Teanaway (Watershed Sciences, 2002)**

Data collected on September 2, 2001. Thermal tolerances (orange dashed lines) from Richter & Kolmes, 2006.

Stream temperatures in the MF and WF were measured via thermal infrared (TIR) remote sensing in 2001 (Watershed Sciences, 2002). Longitudinal temperature data are shown in Figure 15 and Figure 16 below, along with land ownership and thermal tolerances for spring Chinook and steelhead (Richter & Kolmes, 2006). For both the MF and WF, temperatures generally increase as water moves downstream, with the exception of the confined, canyon-like segment in the MF, where temperatures are 4 °C lower than upstream. Watershed Sciences noted a cold side channel above the confined reach, which may be attributed with a floodplain spring brook (Watershed Sciences, 2002). Thermal variability in both the MF and WF is shaped by cold tributary inflows and subsurface exchange within the floodplain, however Watershed Sciences did not sample tributaries to the WF. Review of longitudinal data for the WF shows several locations where coldwater inflows or groundwater exchange reduce stream temperatures in the mainstem WF, such as below the confluence with Corral Creek (RM 6.5) and near RM 1, where several small, unnamed tributaries or springs enter the valley bottom from the north and south (Figure 16). Portions of the lower MF and WF both exceeded thermal tolerances for Chinook during the late summer period when TIR data were collected. Spawning spring Chinook using the MF and WF would need to migrate upstream to cool water habitat from March through May when water levels are higher and temperatures are lower than in the warm summer months (Keefer et al., 2018).

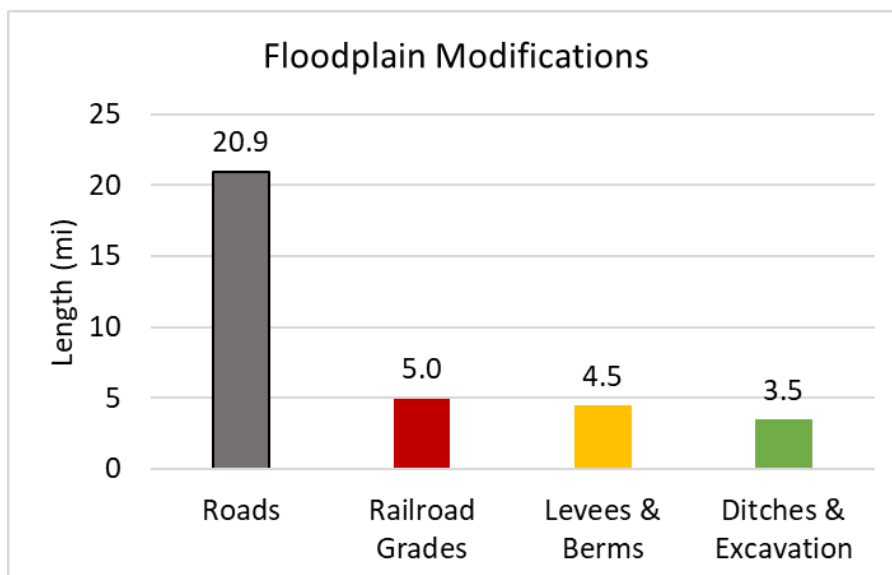
**Figure 20. Floodplain Modifications Mapped in the West and Middle Fork Teanaway Rivers from 2015 and 2018 Lidar**

The geomorphic influence of some these features is noted in the REM descriptions above. Most floodplain modifications within the WF and MF valley bottom and floodplain areas have either existing or historic influence on channel morphology, through confining the active channel, preventing overbank flows, obscuring side channels, or concentrating overbank flow into artificial drainage ditches. Cumulatively, floodplain surface modifications have severely confined the MF and WF Teanaway in many locations, exacerbating historic channel incision by translating stream power into bed scour. Ongoing incision coupled with lateral constraints result in a loss of both vertical and lateral floodplain connectivity. Figure 20 shows two contrasting floodplain areas, where a floodplain modification such as a road grade or berm disconnects the mainstem channel from low-lying floodplain areas; and another where low-lying floodplain channels are well-connected with the mainstem due to a lack of floodplain modifications or artificial channel constraints.

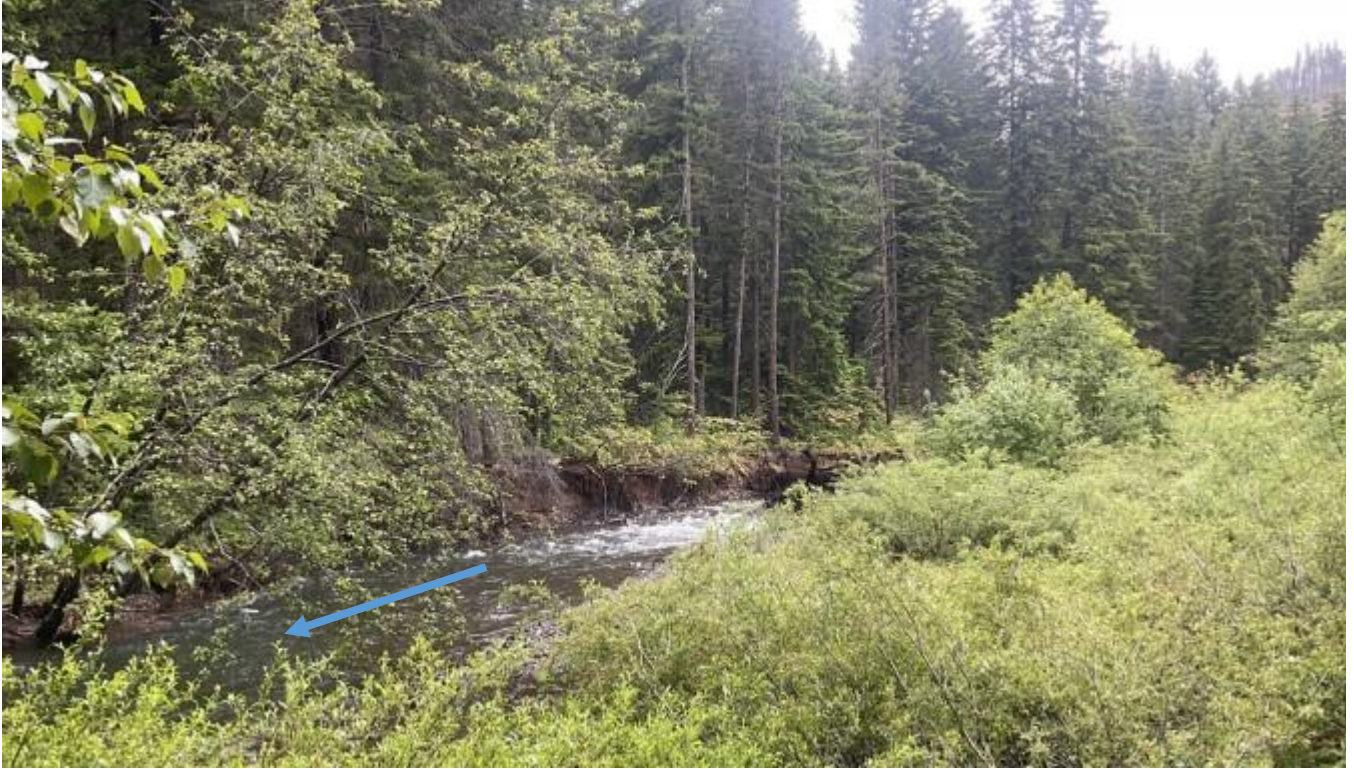
**Figure 22. Example of Eroding Bank near RM 5.1 in the Middle Fork**

Historic channel incision has resulted in over-steepened banks in many locations. Places where channel banks are actively eroding have potential for large wood recruitment, and in many areas these eroding banks have intact riparian canopy (Figure 22). Along the historic floodplain surface, much of this canopy is young coniferous forest with heights up to 100 ft. In low-lying floodplain areas within the active channel corridor, canopy is predominantly low (< 20 ft) alder and willow, with patches of taller (up to 100 ft) cottonwood trees where channel disturbances are limited. In bedrock channel segments, soil substrate is absent or is poorly developed, inhibiting the establishment of riparian vegetation. Locations where intact side channels flowed through floodplain forest or locations with groundwater expression had much greater riparian cover and shading, with channel widths generally between 6 – 20 ft (Figure 23). Numerous historic side channels and floodplain channels were observed during the field visits but few of these channels appeared active or had hydric soils.

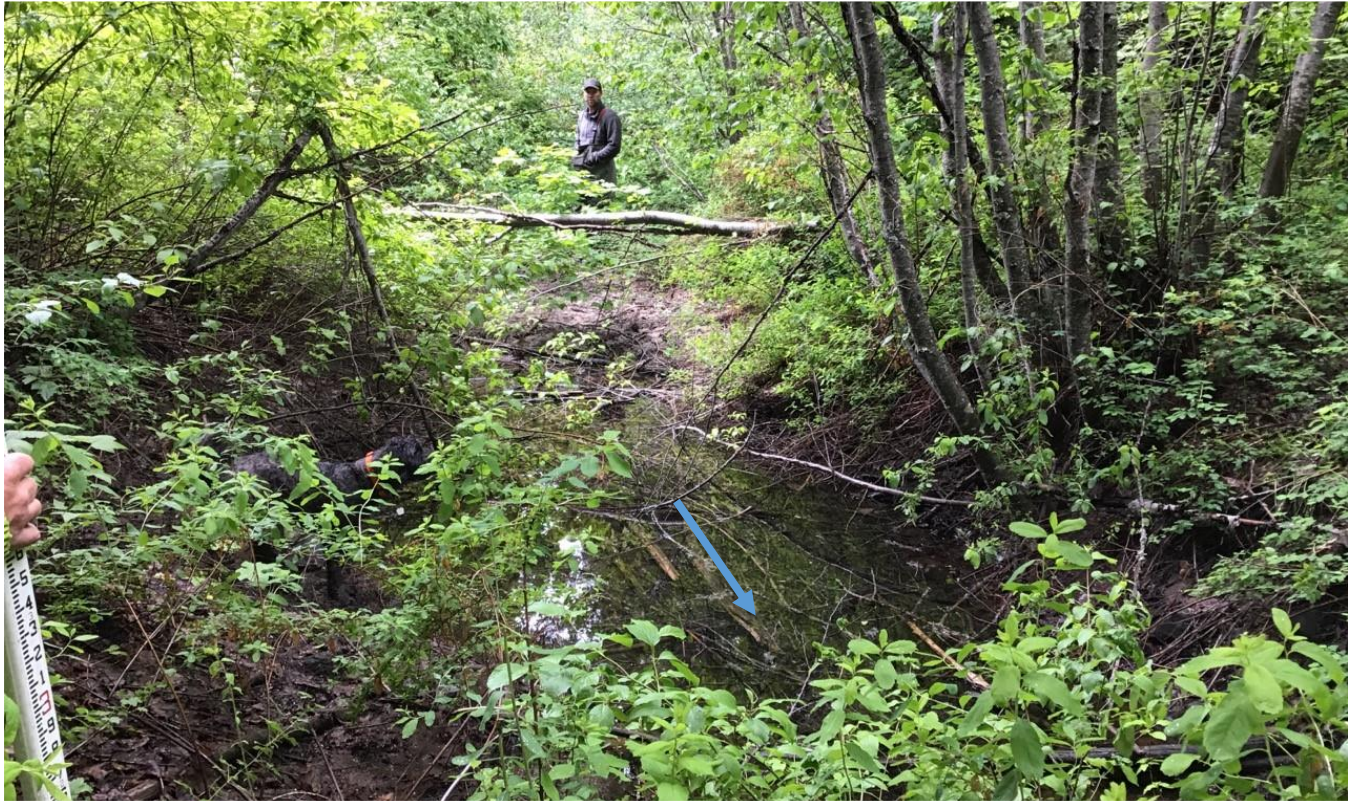
**Figure 23. Groundwater Expression and Riparian Shading in a Floodplain Side Channel near RM 4.7 on the Middle Fork**

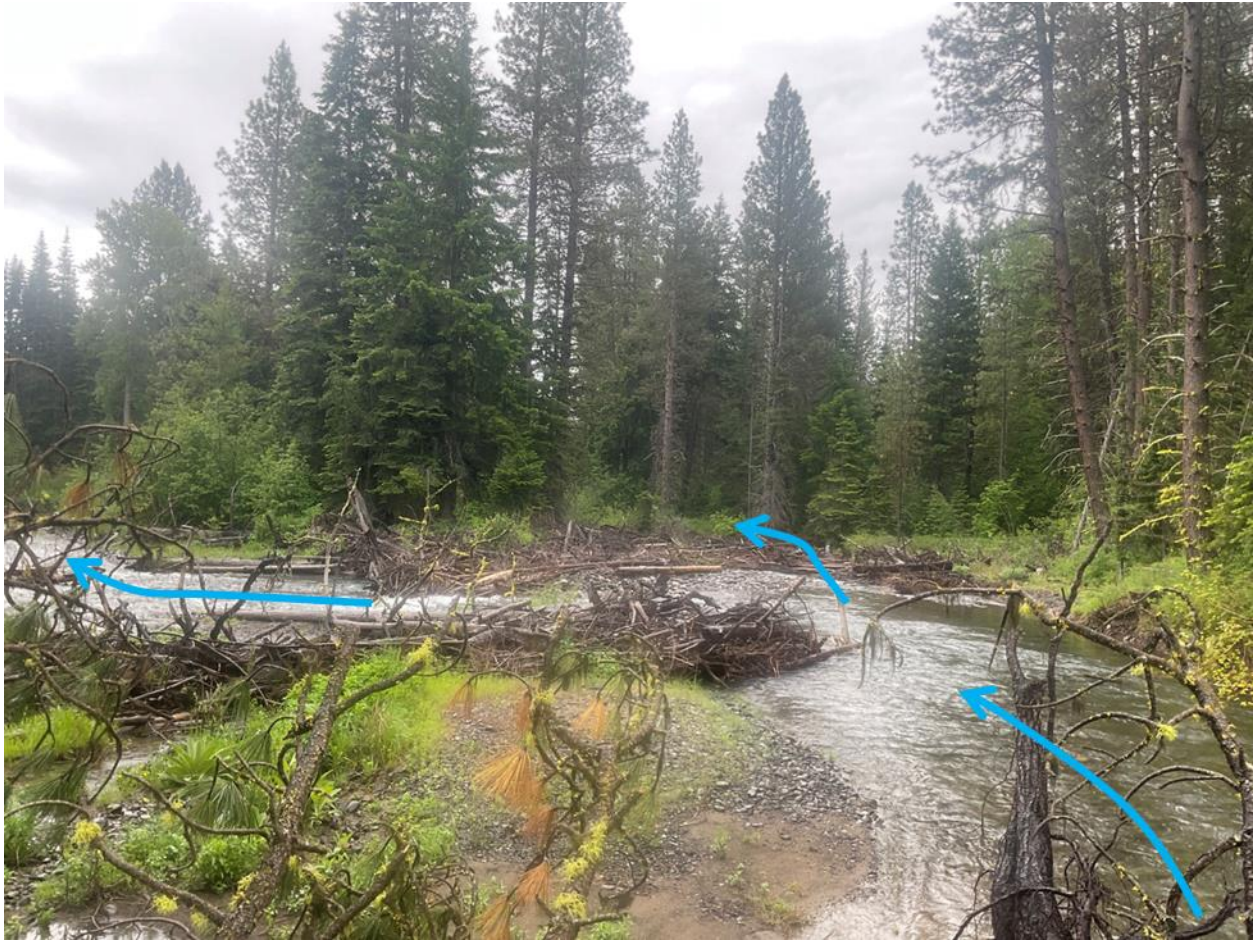
**Figure 24. Logjam and Forested Island near Middle Fork RM 0.7**

*Gravels have deposited in the lee of logjams, with scour pool formation and multiple wetted flow paths. Photo: June 14, 2021.*

Where stable logjams have formed in the Teanaway, multiple flowpaths are wetted, floodplain side channels are engaged, wood-forced pools have formed, and in one location a forested island is present (Figure 24). Without key-sized pieces with intact rootwads, even logjams that remain stable for several years can be broken-up or washed-out during larger flood events. The logjam complex near RM 0.7 on the MF formed following rapid channel expansion upstream during heavy flooding in March 2007 (10 – 20 year flood; Figure 25). In subsequent years, the anabranching channel segment that is still present formed around this logjam, creating a forested island. Ongoing channel expansion during a 2009 flood event (~5 year flood) delivered more wood to the logjam complex, expanding upstream to engage side channels in the left bank floodplain (Figure 25). By 2014 the logjam had grown to nearly half an acre in size, but then broke up prior to the 2017 aerial image, likely during the 2016 flood (25 year flood; Figure 26). Additional wood recruitment in this location occurred in water year 2021.

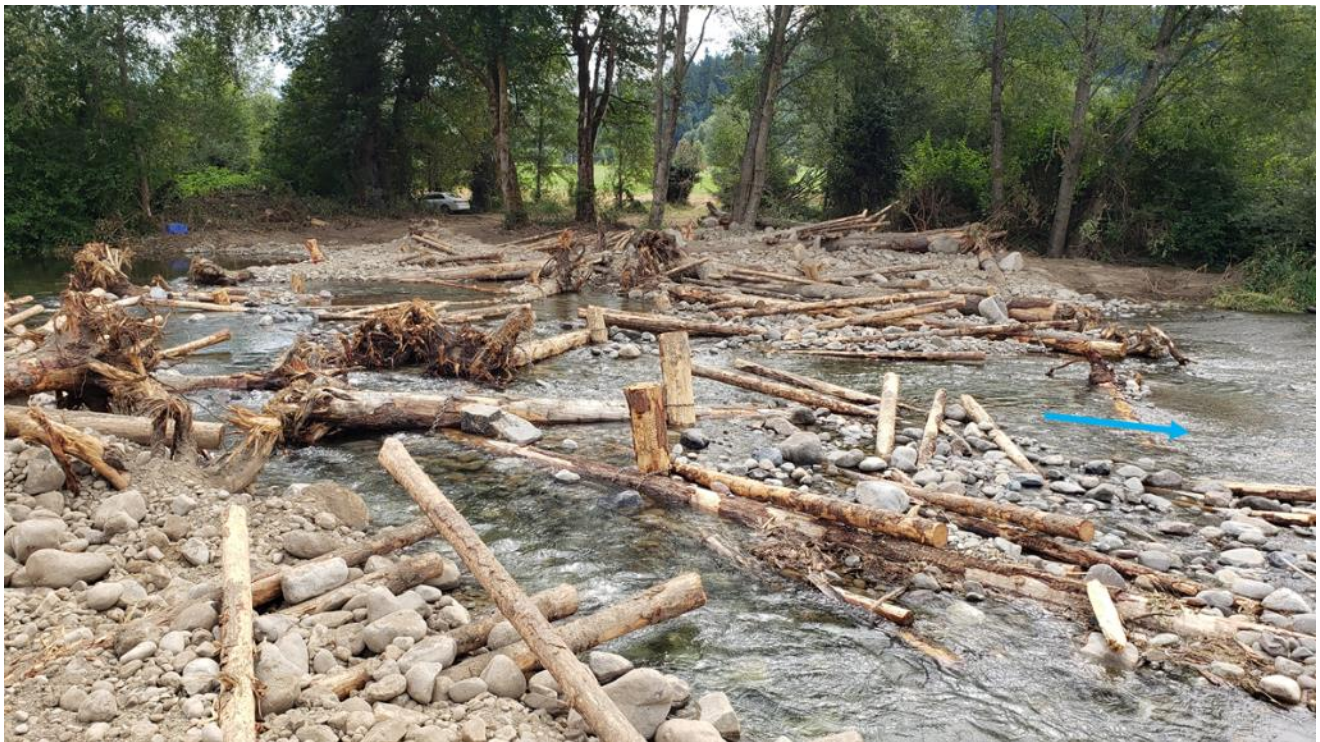
**Figure 27. Channel-Spanning Engineered Logjam in South Prairie Creek, Pierce County, Washington Immediately following Construction**

Historic incision and floodplain modifications in the Teanaway have led to an overall reduction in channel length and the frequency and extent of floodplain engagement. Restoring vertical and lateral connectivity with the floodplain will increase water storage and habitat availability, promote the formation of wetlands, and reduce stream power and sediment losses by partitioning flows. The existing conditions hydraulic model output from YN was used to assess current inundation and channel length for the 2-year flow. For locations where large wood and/or fill are proposed in the stream channel, the existing WSE was raised by the conceptual design height for those restoration treatments (typically 2-4 ft). Similarly, for locations where side channel excavations are proposed in ROAs, the ground surface was lowered by the conceptual design height (typically 1-4 ft). The resulting conceptual WSE was then used to evaluate potential floodplain inundation and channel length resulting from restoration treatments. Each ROA was then scored based on the percent increase in inundated area and channel length. Channel-spanning (valley) logjams have been successfully used to aggrade the South Fork Nooksack (Abbe et al., 2015) and South Prairie Creek (Figure 27). Arrays of large bar apex jams have been successfully used on numerous rivers to restore anabranching, channel complexity and trigger channel aggradation (Abbe and Brooks 2011, Abbe et al., 2016, 2018).

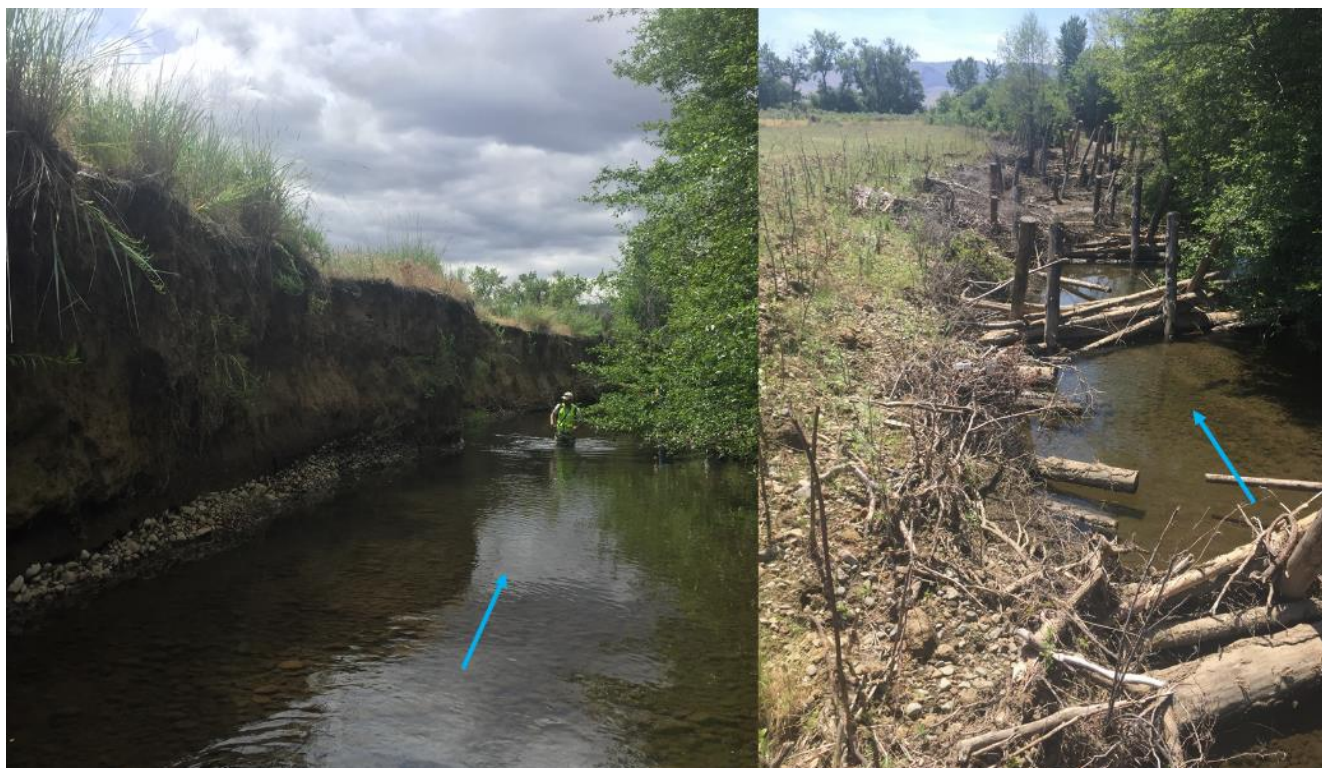
**Figure 30. Example of before (L) and after (R) Valley Reset Large Wood Restoration in Toppenish Creek**
